Test Report

Report No.: THZJ23021744225EN

Applicant : PT. FORTINDO SUKSES MAKMUR
Address : KOMP.PERGUDANGAN PRIMA CENTER 1 EXT BLOK F NO.12
RT.009 RW 002 KEL KEDAUNG KALIANGKE,KEC
CENGKARENG,JAKARTA BARAT
Sample Name : STAINLESS PANEL BOX
Model No. : FSBI806030
Manufacturer : YUEQING KIBOX ELECTRIC CO.,LTD
Address : NO 12,XINGGUANG ROAD,XINGGUANG INDUSTRIAL ZONE,LIUSHI,
WENZHOU,CHINA
Brand :  
Date Received : February 18, 2023
Test Period : February 18, 2023---February 20, 2023
Test Requested : IP 65
Test Method : IEC 60529: 2013
Test Result : Pass

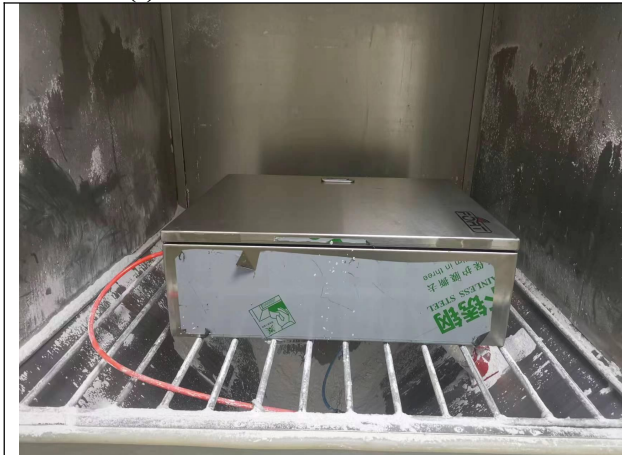
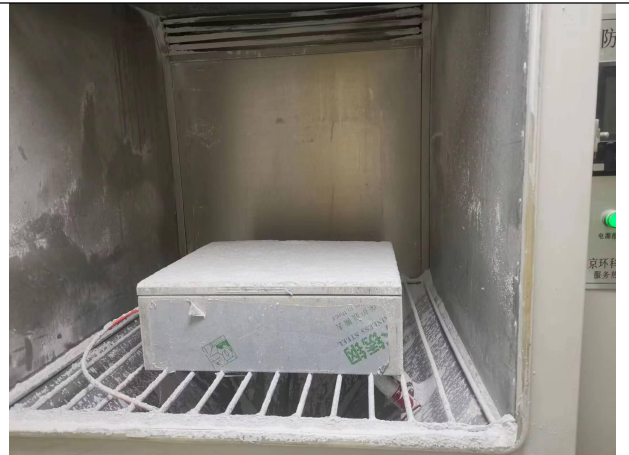
Test Setup: Dust-proof chamber, Model No. SC-010

Test Conditions:
 1) Maximum depression : 2kPa.
 2) Test period: 8 hours
 3) Extraction rate: 40 volumes per hour

During Test

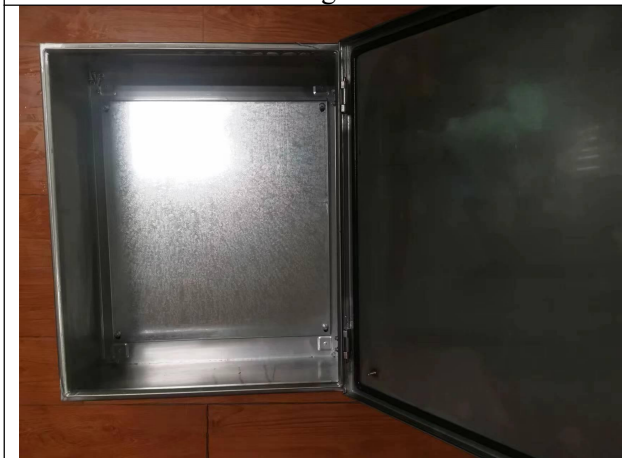
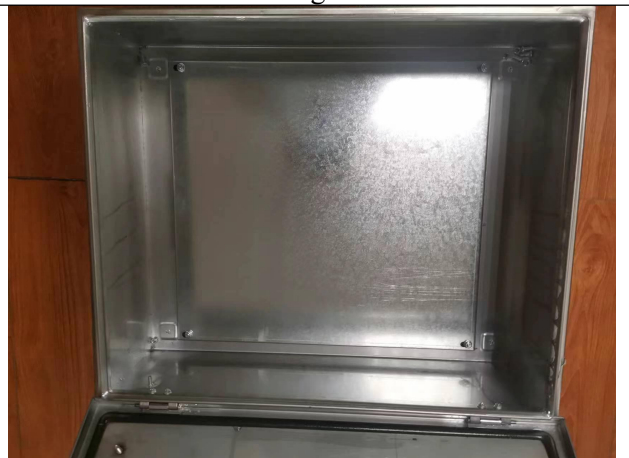
Sample Name	Test Results
PANEL BOX	No dust observed inside the test sample

After Test
